# BUILDING INSPECTION REPORT

## Dufferin Grove Park

Components: Waterplay

Date of Audit: 20 April 2005

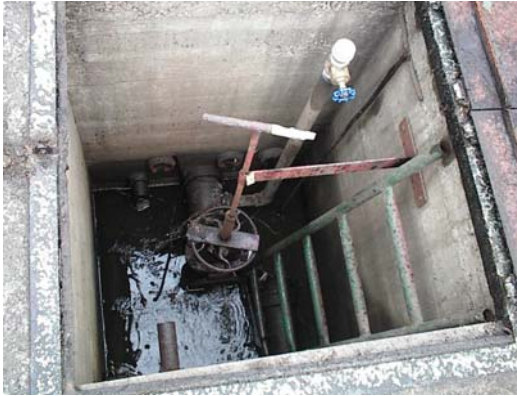
0411WP\_PM01 Underground sump with water drain, drain valve and drain to sewer.

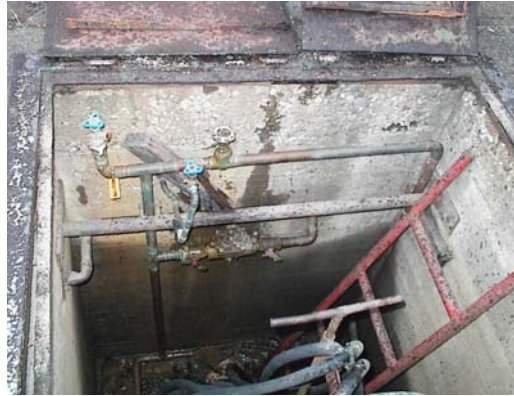
0411WP\_PM02 supply valve chamber (underground) with water supply to pool and drinking fountain and fill valve.

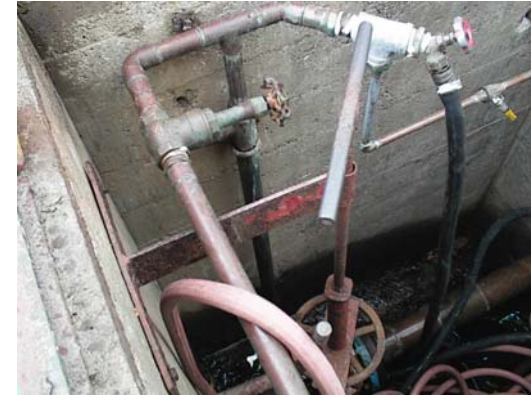
0411WP\_PM03 supply valve chamber (underground)

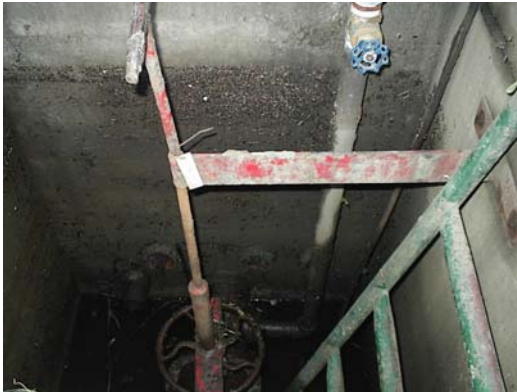
0411WP\_PM04 Sump with drain valve

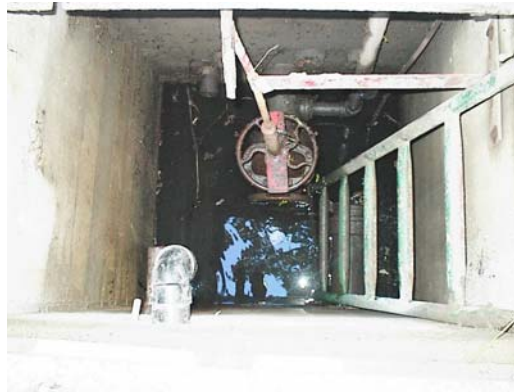
0411WP\_PM05 Sump with drain valve

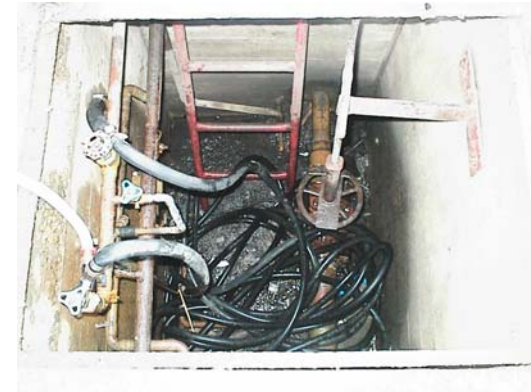
0411WP\_PM06 Drain

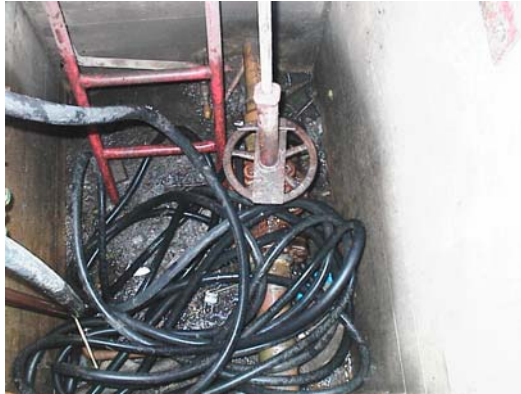
9.0	Summary	AS01									Landscaping around pool area is poor, replace grass around pool is strongly recommended.
		CLD01									Camera inspection completed on drain line and supply line. Electronic leak check and pressure test carried out on spray nozzle spray. Spray nozzle supply test OK. Gate valve for main supply leaking.

0411WP\_PM07 Leaking valve in supply valve chamber

7.0	Total							12	170		181
8.0	Comments	A01									provide new barrier-free pathway to wading pool.
		A02									repair push button & concrete pad for drinking fountain.
		A03									500m² grass surface around wading pool to be replaced
		M01									replace existing 3" water supply shut-off valve with new.
		M02									loosed Ø20 water outlet to be fixed.
		S01									replace concrete floor
		S02									repaint concrete pool surface.

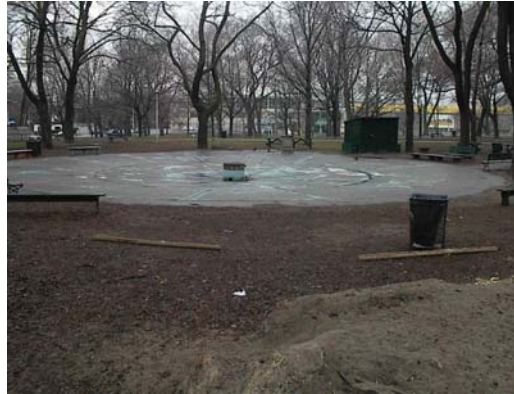
S01 pool is overall in pool condition. A replacement of concrete floor cover with under-ground piping is recommended but concrete valve chamber can be reused.

0411WP\_PS01 Overview (West): site lighting, garbage bin and concrete pedestal in the middle of the pool.

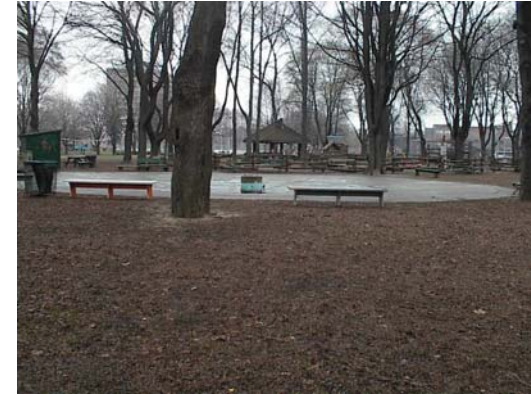
0411WP\_PS02 Overview (North): benches and playground at the North.

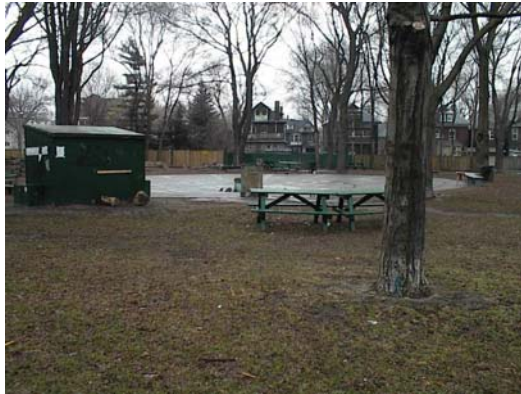
0411WP\_PS03 Overview (Northeast) : Tool room at the west of the pool. Grassy area and Benches
