BUILDING INSPECTION REPORT

CITY OF TORONTO - EDCT DEPARTMENT

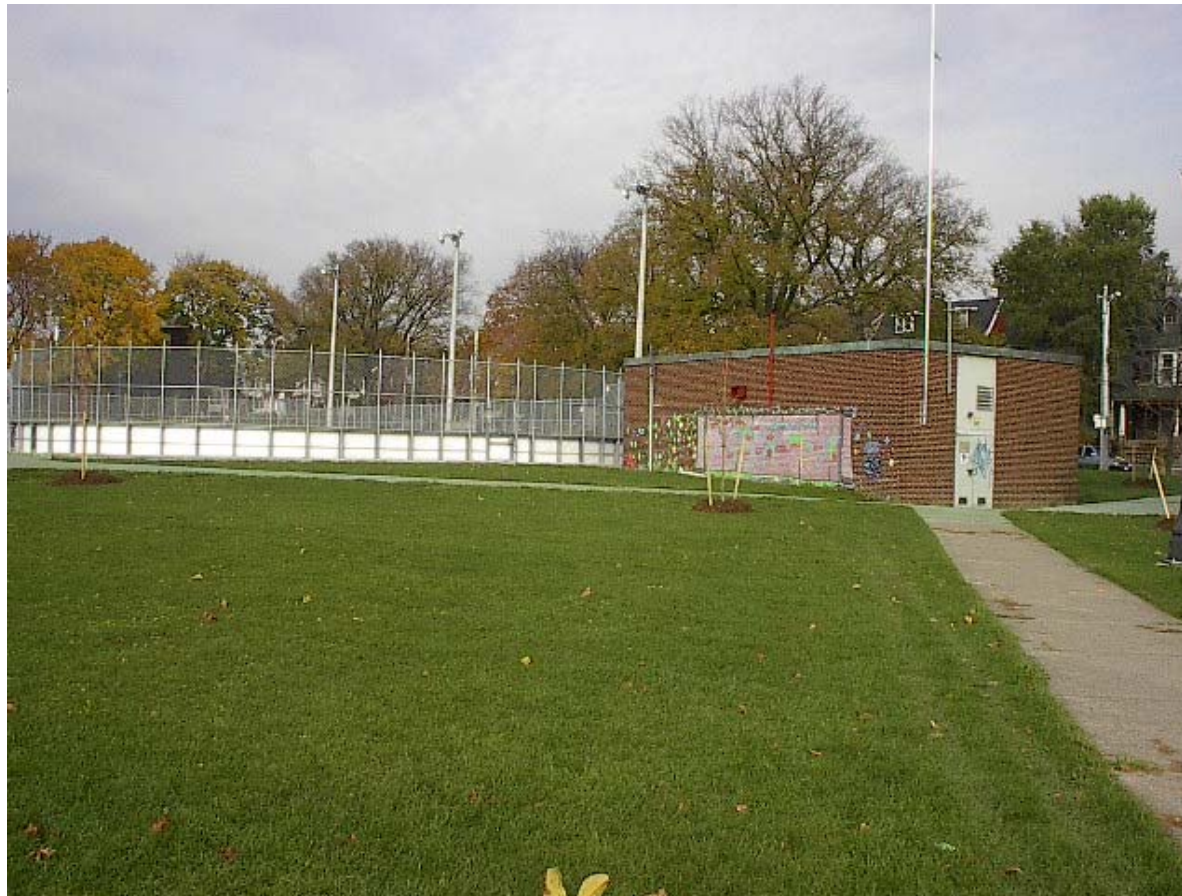
BUILDING INSPECTION REPORT

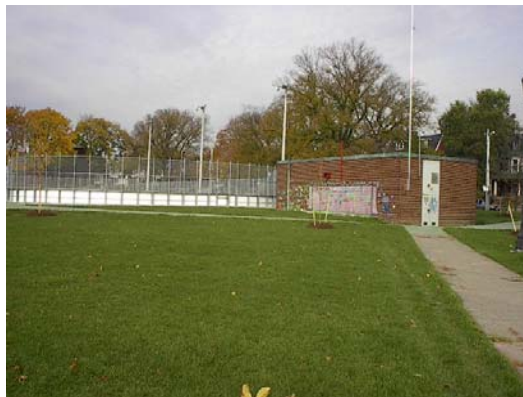
S11-001-R-Bellwoods Front view

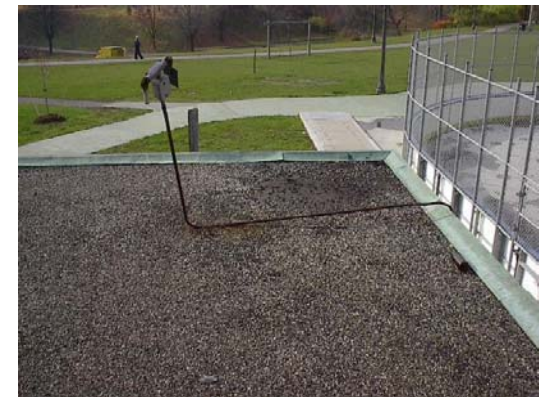
S11-003-R-Bellwoods Exposed/deteriorated membrane at the corner of the roof. Also, sensor on the corner on the roof is not supported.

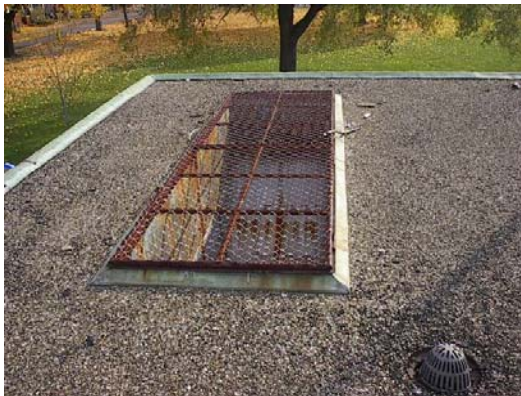
S11-004-R-Bellwoods View of the roof, exhaust curb very low at the roof level.
