**BUILDING INSPECTION REPORT**

**CITY OF TORONTO - EDCT DEPARTMENT**

**Campbell Park AIR**

**Address** 255 Campbell Ave.

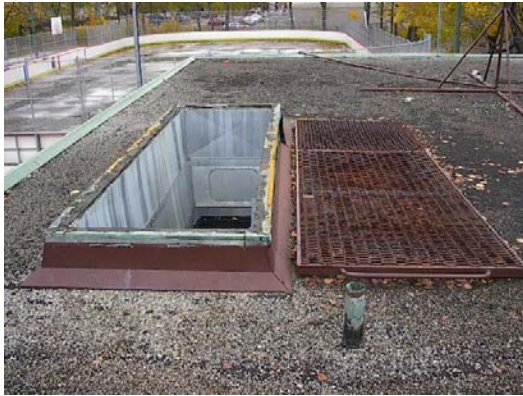
S45-004-R-CampbellPk Exhaust curb on the roof is too low and cover is not installed.

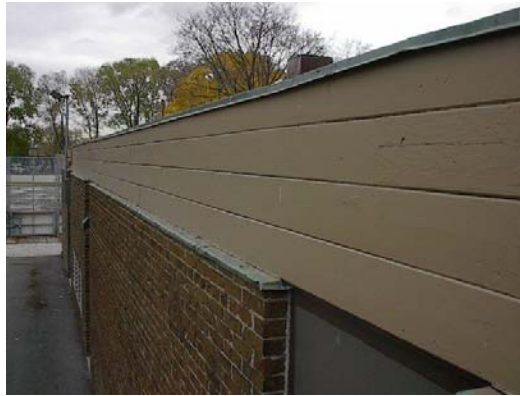
S45-005-R-CampbellPk Through wall flashing between the brick and the wood is copper and very old and damaged.

Life Exp	Year Install	Remain Life	Condition	Priority	Funding Level	\$ '000		Photo Ref #	Notes / Comment Ref #
						R & M	+ Capital = TOTAL		
R07				Priority 2: Replace copper flashing on top of the masonry brick wall.					
R08				Priority 2: Existing Ammonia Diffuser is corroded, to be replaced & relocated far from Evaporative Condenser air out.					
R09				Priority 2: Replace existing floor drains with funnel type to avoid any spills.					
R10				Priority 2: Provide storage for refrigeration.					
R11				Priority 2: Extend brine header vents to avoid spill. Remove all disconnected pipes from old system.					
R12				Priority 2: Existing baseboard heaters located on floor, fins are broken & very often heaters in water when sump pit is not capable to handle flood. Replace					
R13				Priority 1: Life Safety: The following items shall be supplied and installed: smoke and heat detectors, bells, voice communication, extinguisher in mechanical room and emergency lighting and control.

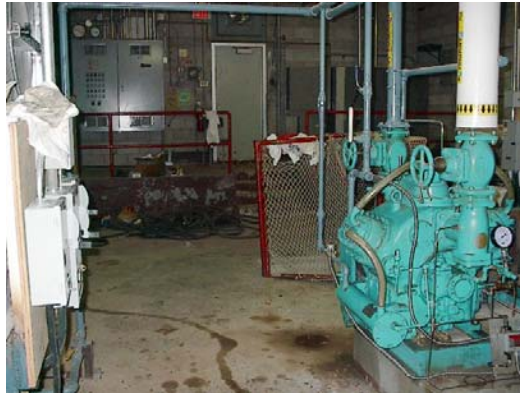
S45-008-R-CampbellPk View of the mech. room, Note that nets are being stored inside the room.

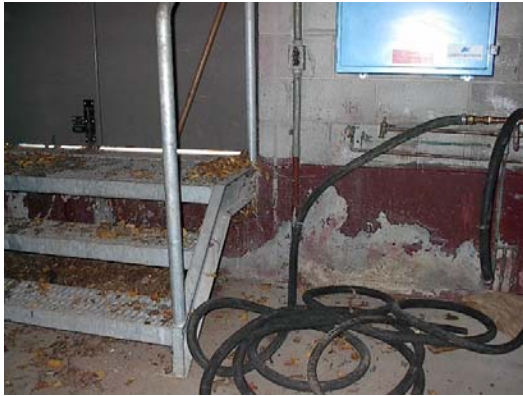
S45-009-R-CampbellPk Bottom of the door does not have any weather proofing and as a result, moisture comes to the inside and wetting the concrete foundation wall, note paint is peeling.

R01									Priority 3: Grind and paint metal cover of the trench.
R02									Priority 4: Paint concrete floor slab.
R03									Priority 3: Install one new door.
R04									Priority 2: Replace roofing system.
R05									Priority 3: Replace one exterior door.
R06									Priority 2: Installed weather strip of the bottom of the exterior door to mechanical room.
